Debris/Ice/TPS Assessment and Integrated Photographic Analysis of Shuttle Mission STS-76

*Process Engineering/Mechanical System Division/ET-SRB Branch,
Kennedy Space Center, Florida*

**DEBRIS/ICE/TPS ASSESSMENT
AND
INTEGRATED PHOTOGRAPHIC ANALYSIS
OF
SHUTTLE MISSION STS-76**

22 March 1996

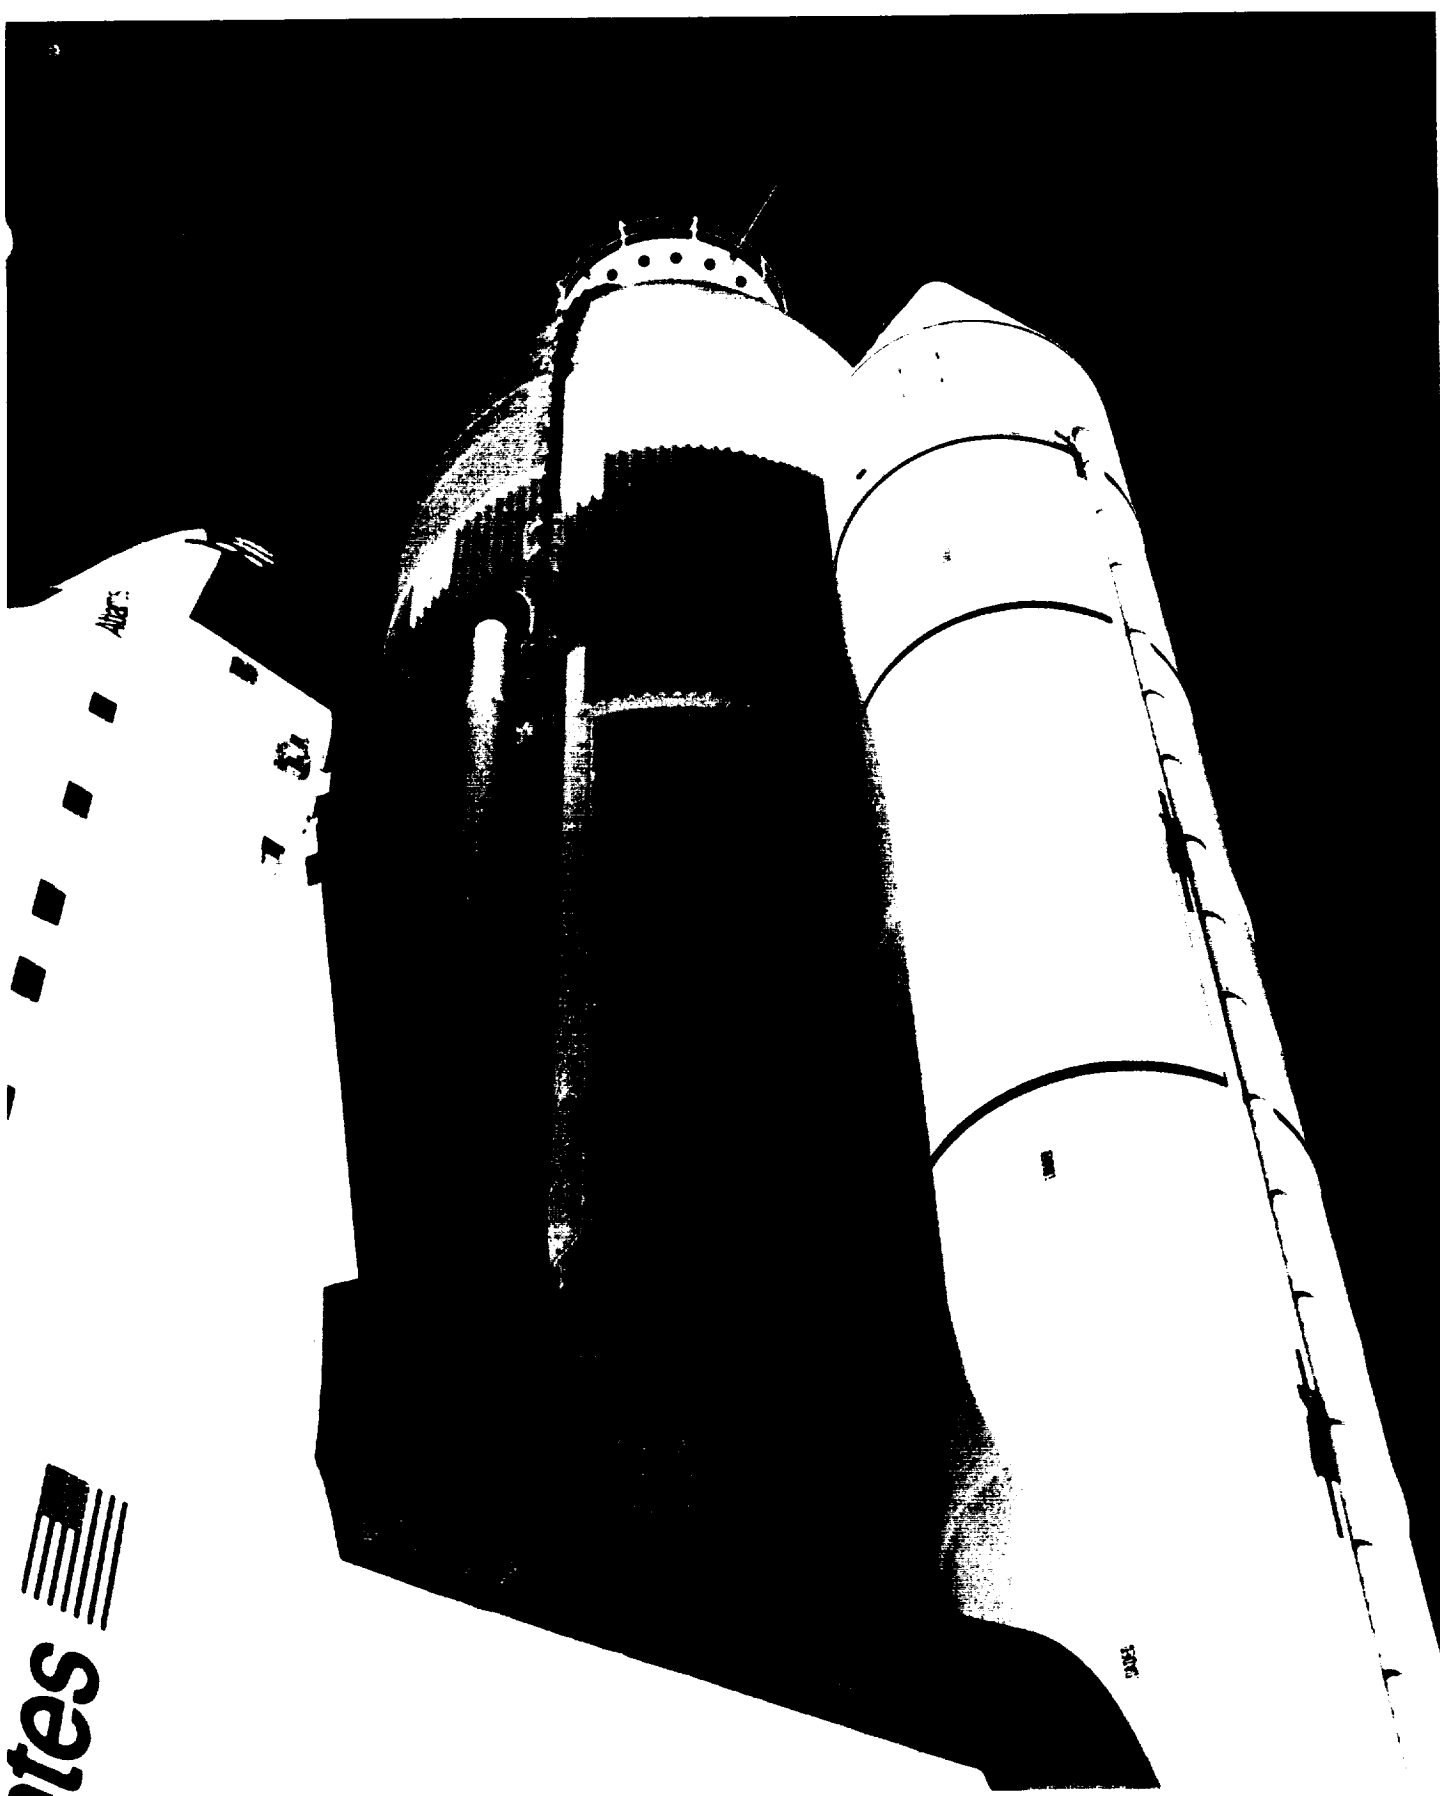
Photo 2: ET-77 Cryoloaded for Launch

The Final Inspection Team observed dry TPS on the LH2 tank. Frost and very light condensate, but no detectable ice, accumulated on the LH2 tank barrel +Y side.

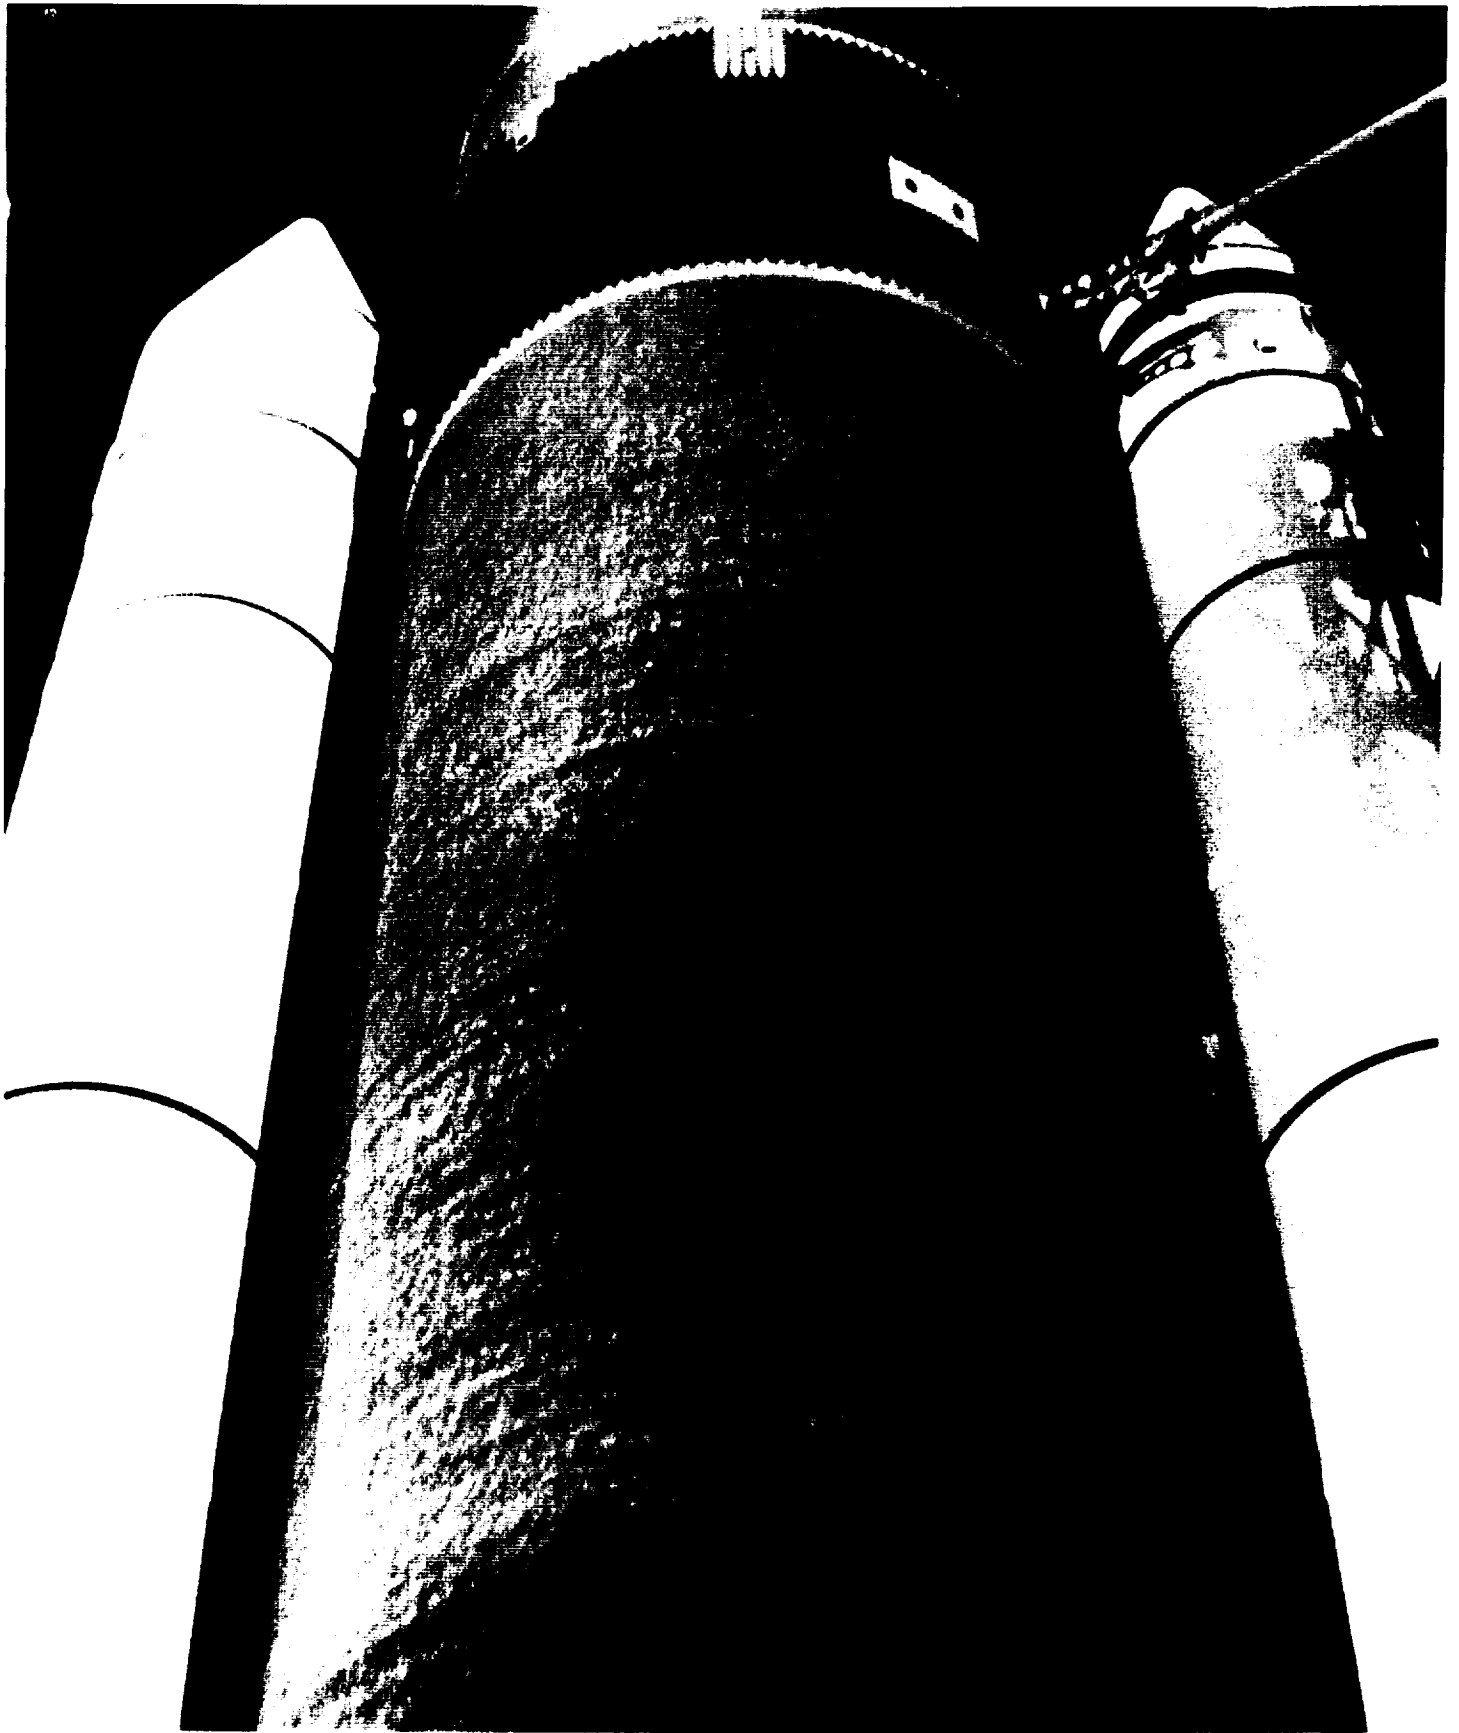
Photo 4: ET Intertank and LH2 Tank Barrel After Cryoload

The intertank acreage exhibited no TPS anomalies. Light condensate and frost, but no detectable ice accumulation, was present on the acreage. Most of the frost had formed in the +Y+Z and +Y-Z quadrants.

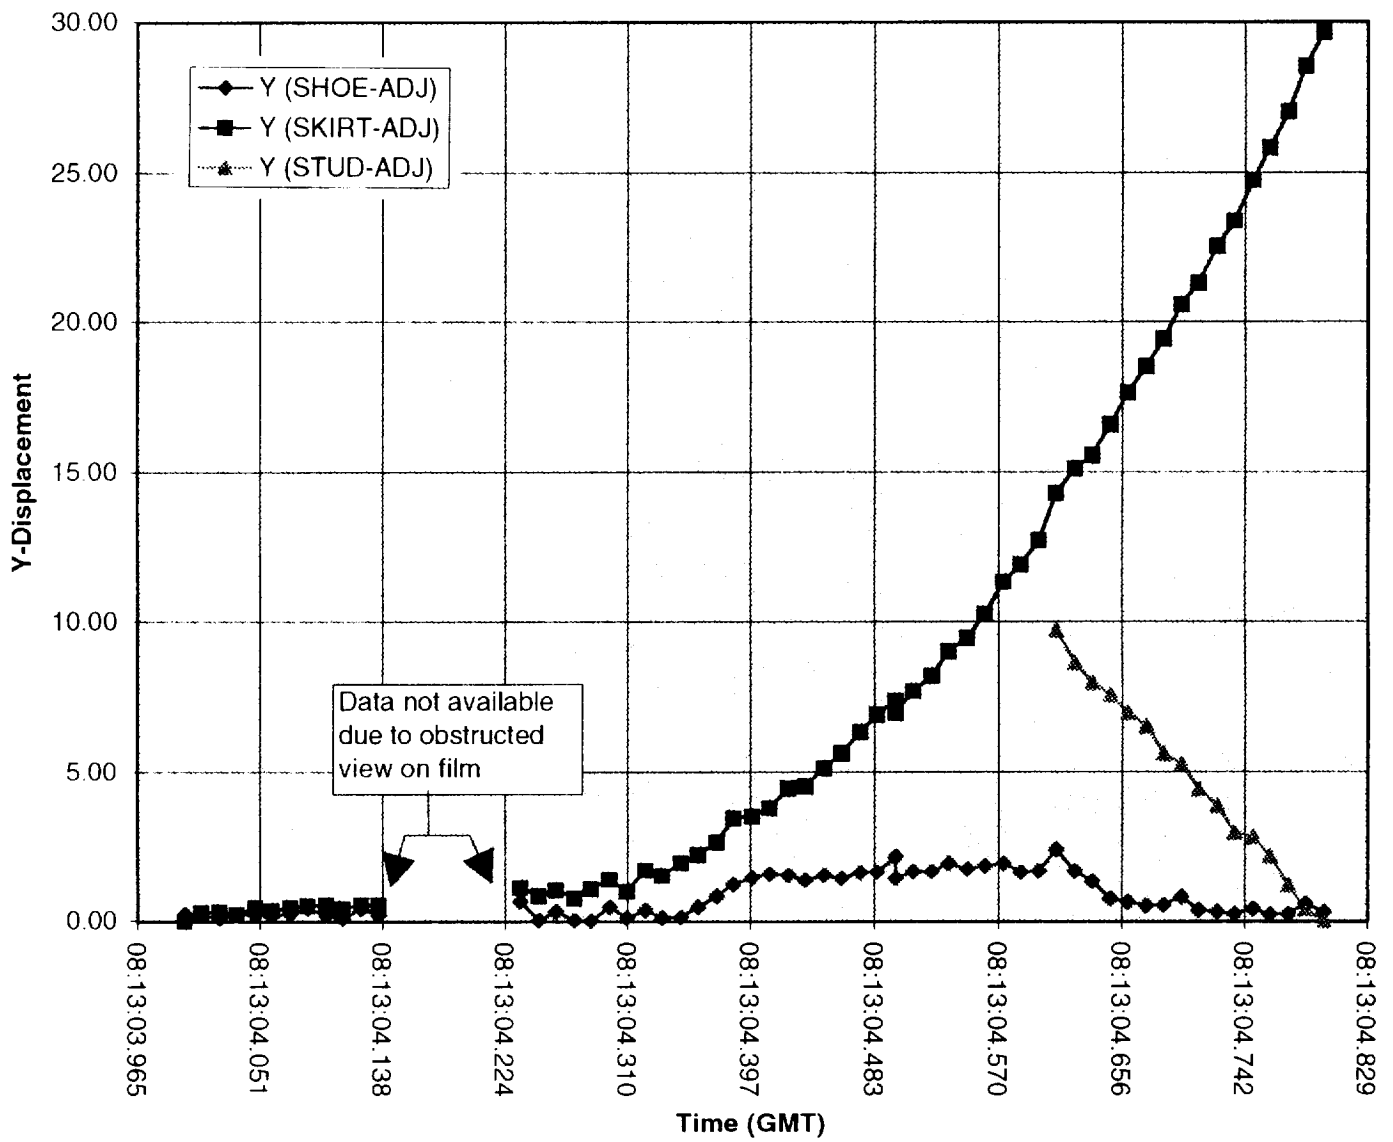
Figure 4: Holddown Post #5 Stud Hang-Up

A stud hang-up occurred on holddown post #5. Drag from the stud hang-up and the rising vehicle lifted the holddown post shoe 2.4 inches before the stud cleared the SRB aft skirt foot (Figure 4). The stud did not appear to gouge aluminum from the stud hole wall. Unlike the STS-75 stud hang-up, no aluminum was observed in the stud threads or falling away from the stud hole. No loose ordnance fragments or frangible nut pieces from the DCS were detected (E-8). No stud hang-ups occurred on any of the other holddown posts. No ordnance fragments or frangible nut pieces fell from any of the DCS/stud holes.

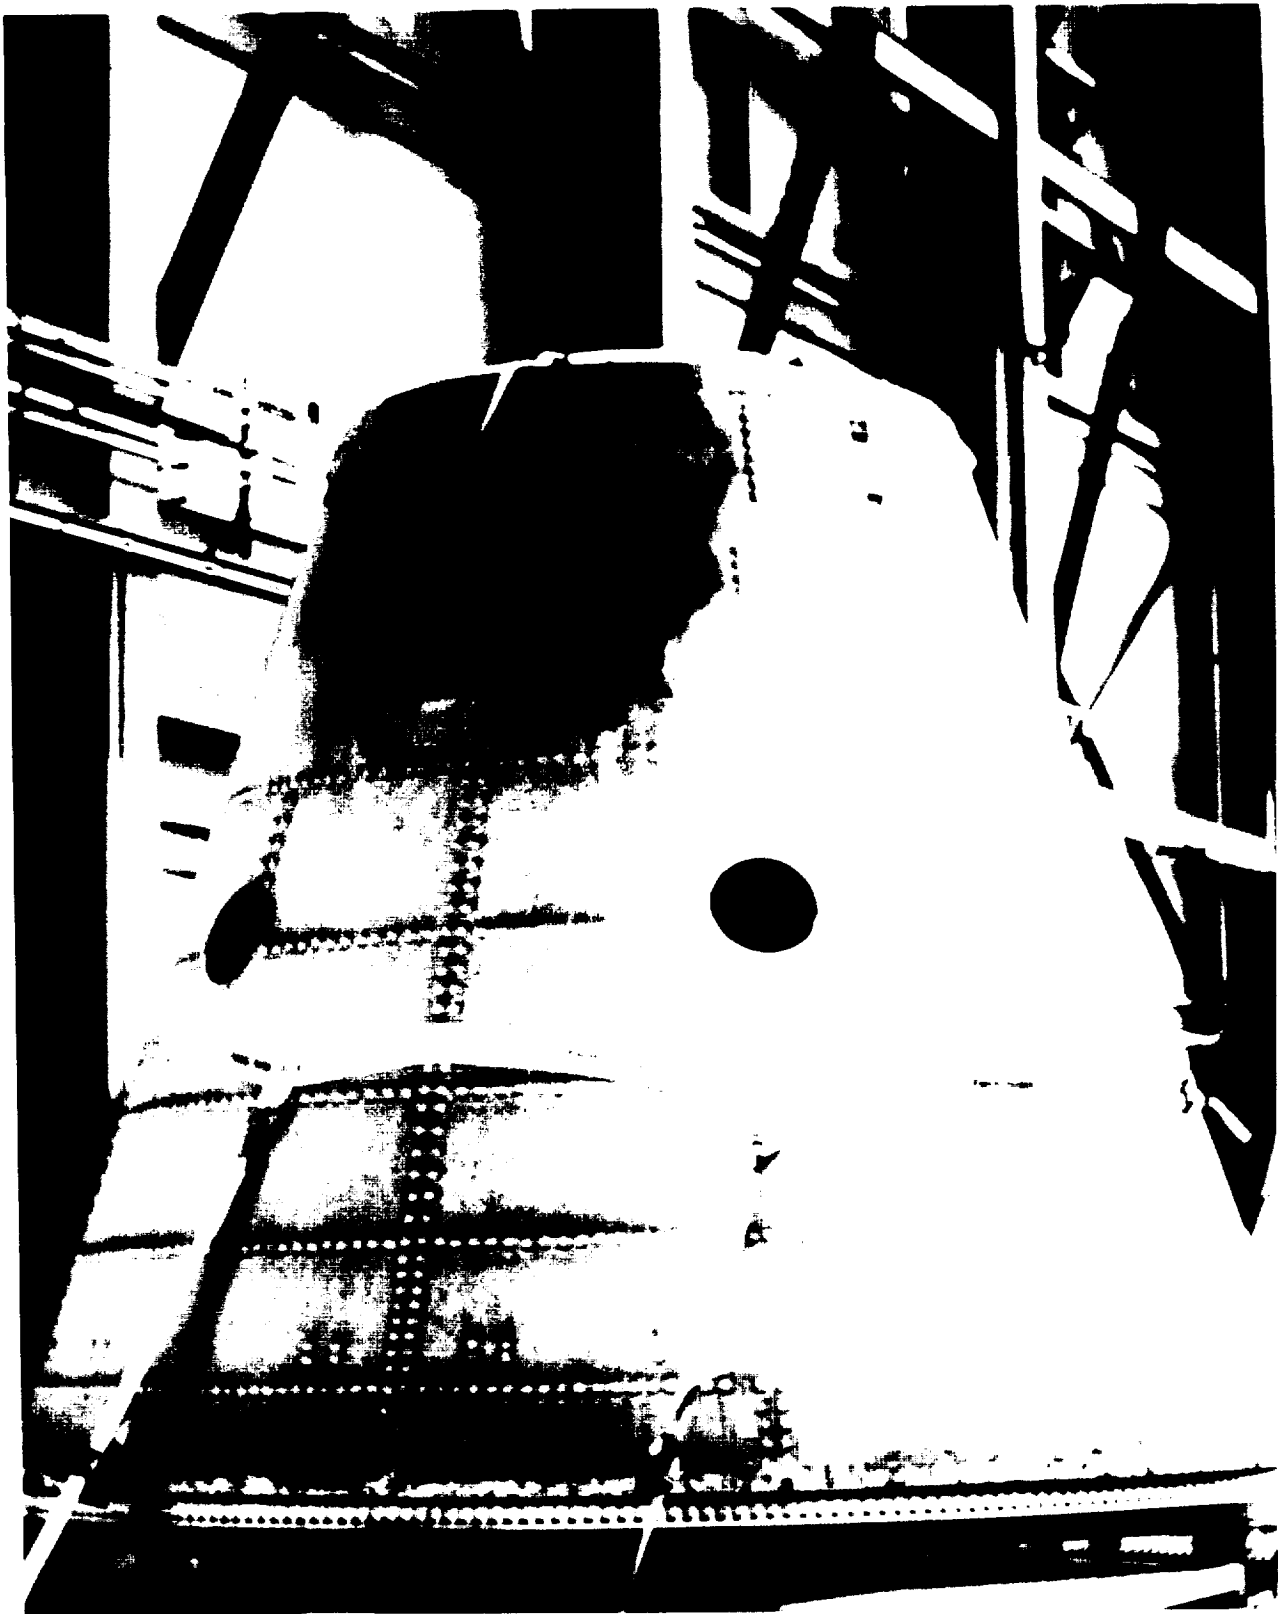
Photo 14: RH Frustum

The RH frustum was missing no TPS. The number of debonds over fasteners (11) was less than average. Hypalon paint was blistered/missing along the XB-395 ring frame where BTA closeouts had been applied. However, most of the exposed BTA substrate was not sooted. The BSM aero heat shield covers had locked in the fully opened position.

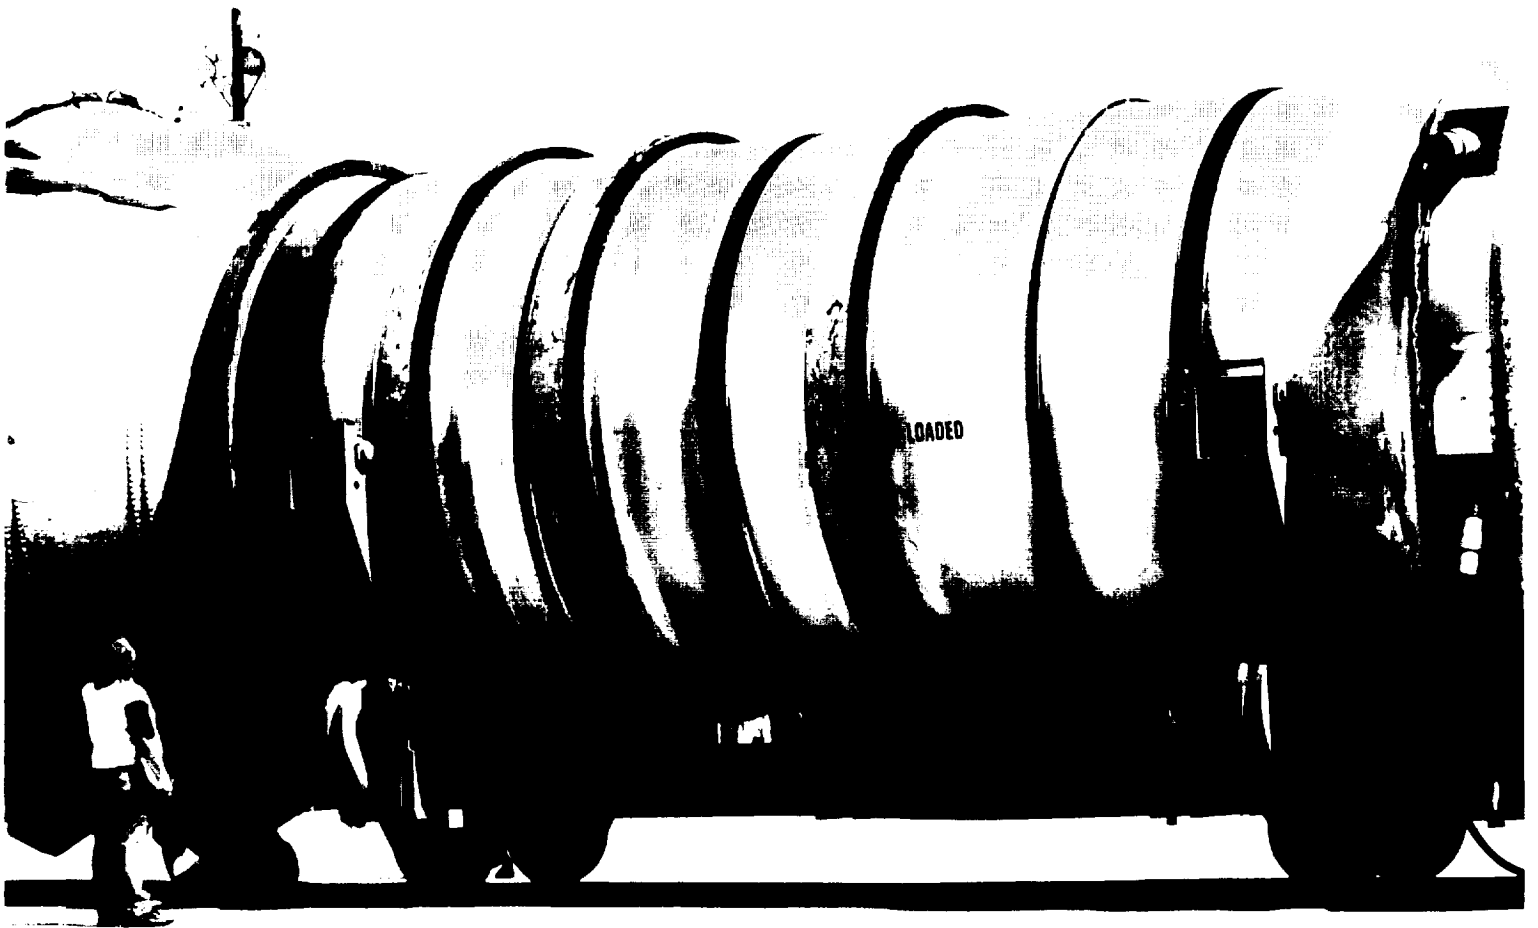
Photo 16: RH Aft Booster/ Aft Skirt

Aft skirt MSA-2 was intact. More than usual amounts of foam were missing from the aft skirt aft ring. This condition was probably the result of the foam adhesion problem documented prior to launch. Launch films showed numerous light colored particles, believed to be pieces of foam, falling along side the SRB plumes during ascent. The HDP Debris Containment Systems (DCS) appeared to have functioned properly and all the plungers were seated.

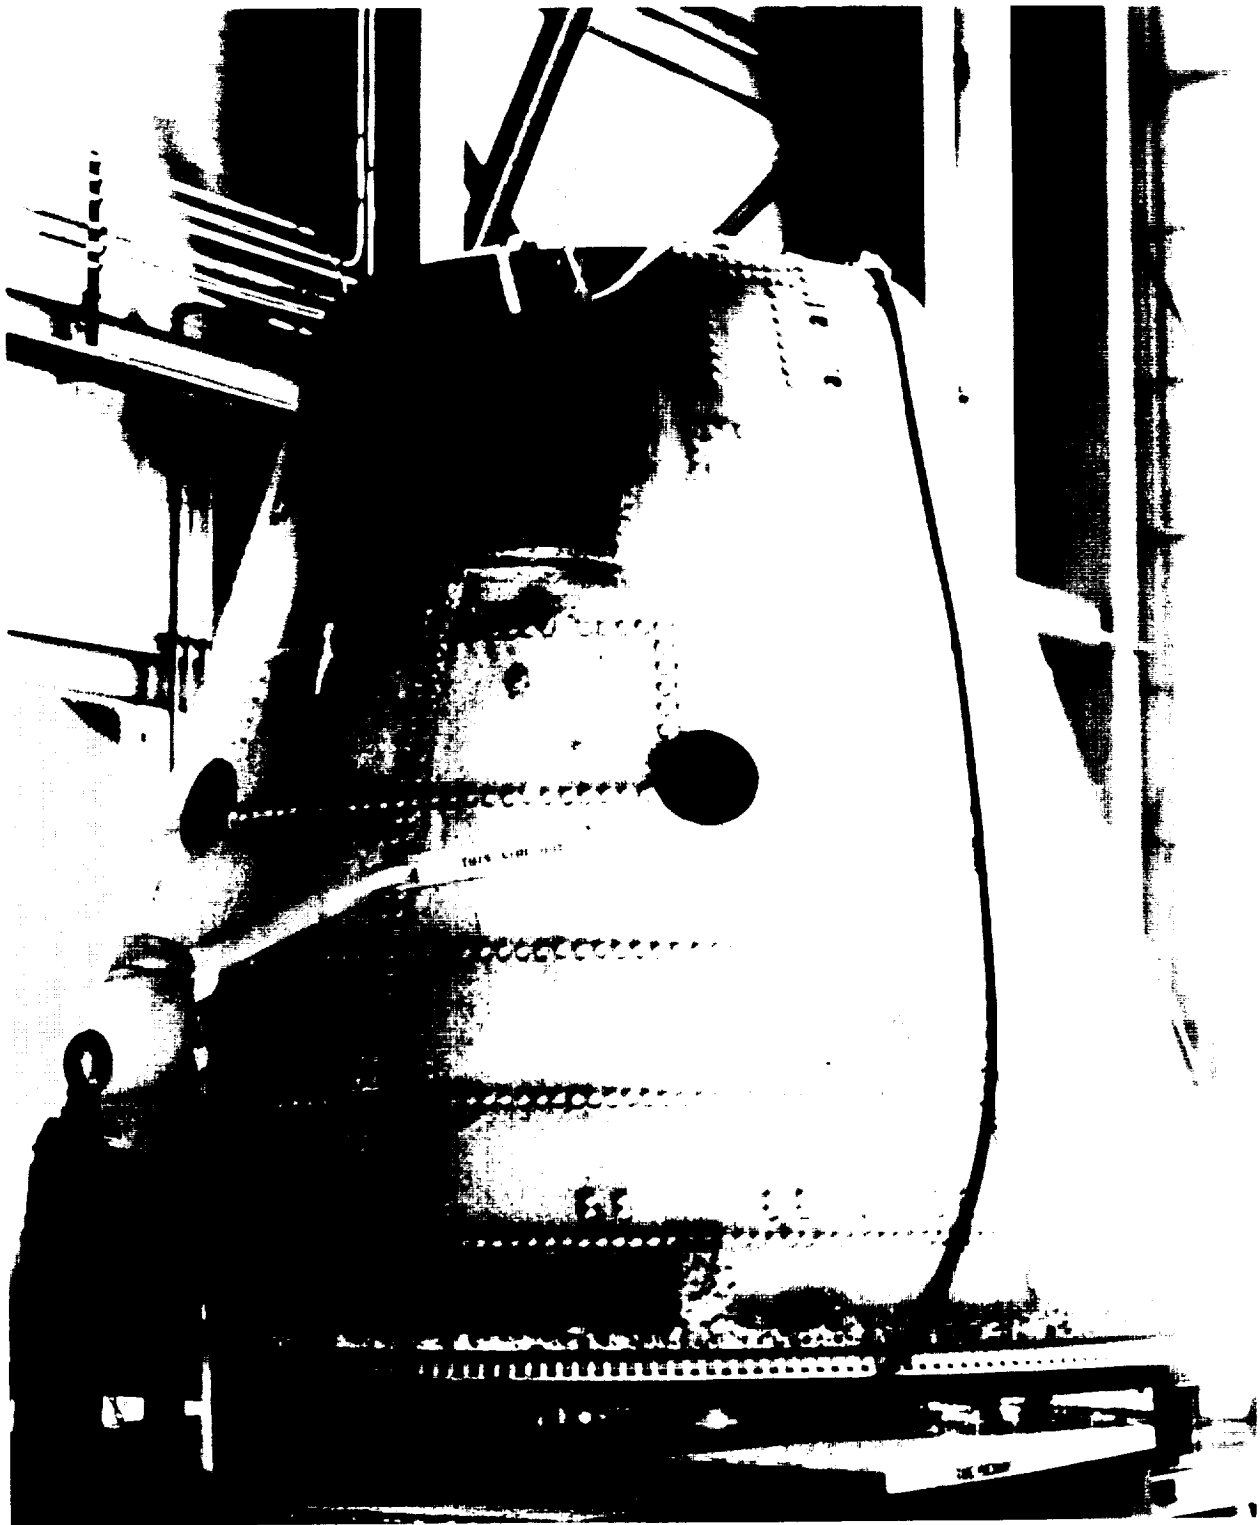
Photo 17: LH Frustum

The LH frustum was missing no TPS. The number of MSA-2 debonds over fasteners (8) was less than average. Hypalon paint was blistered/missing along the XB-395 ring frame where BTA closeouts had been applied. However, most of the exposed BTA substrate was not sooted. The BSM aero heat shield covers had locked in the fully opened position though the right two cover attach rings had been bent by parachute entanglement

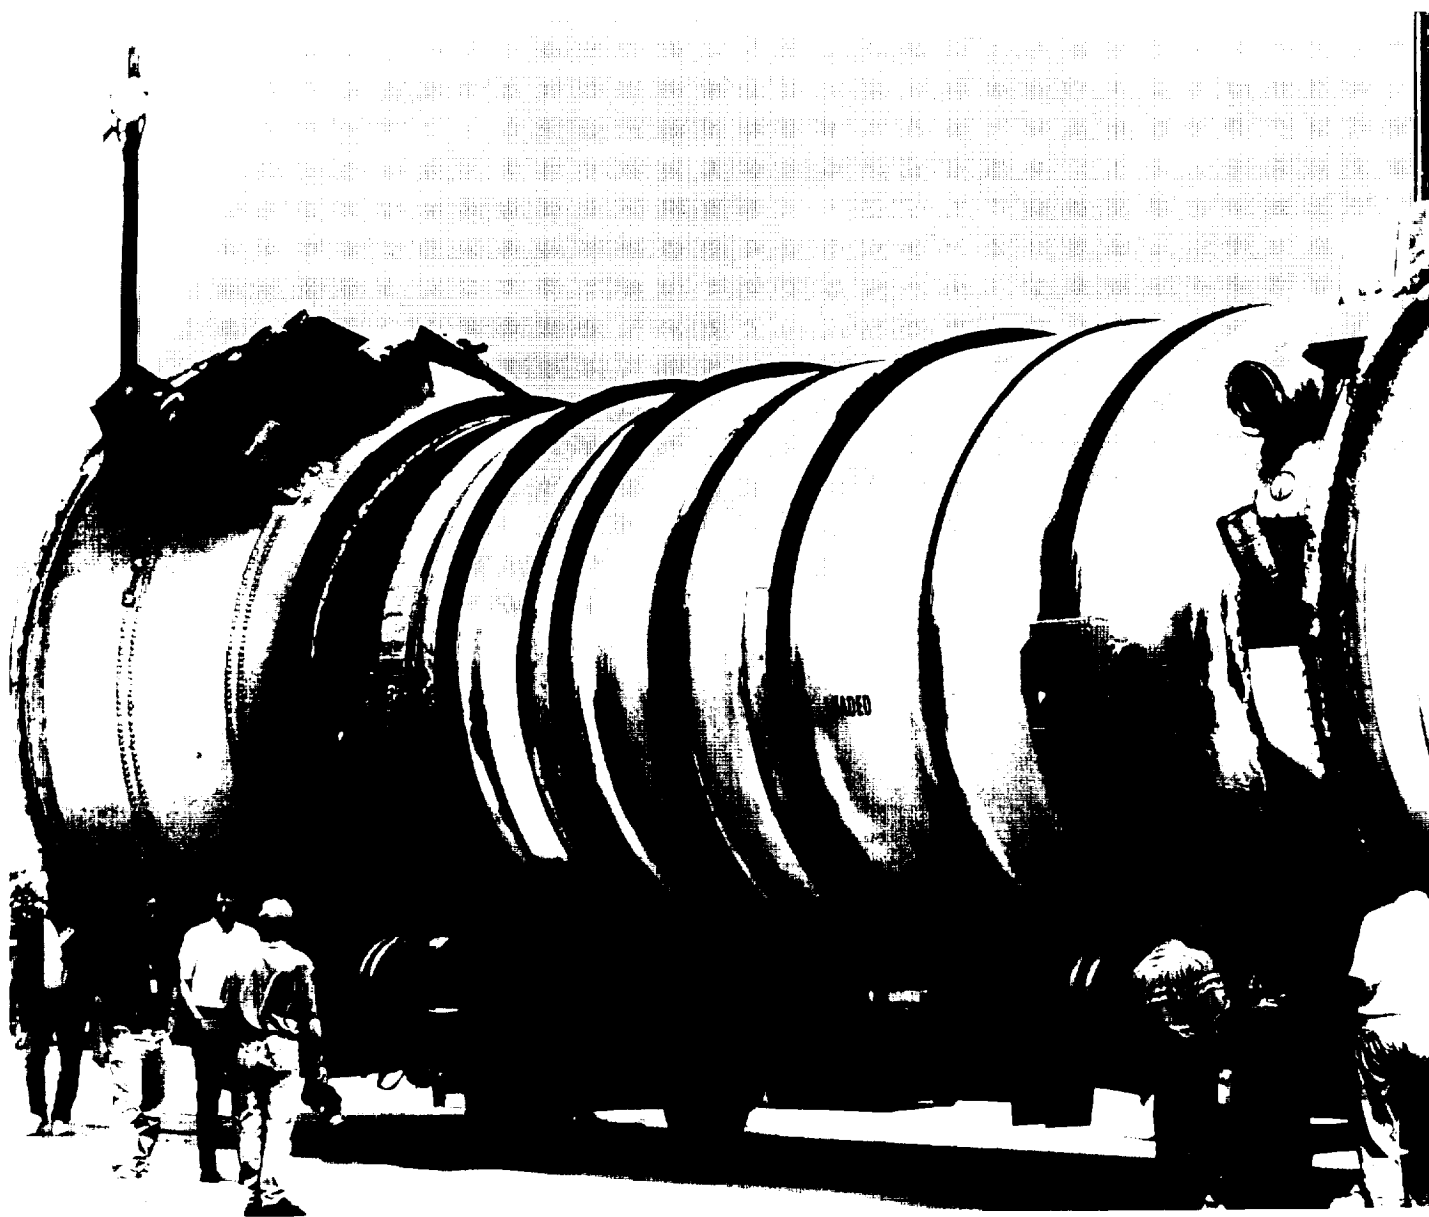
Photo 19: LH Aft Booster/ Aft Skirt

Aft skirt MSA-2 was intact. More than usual amounts of foam were missing from the aft skirt aft ring. This condition was probably the result of the foam adhesion problem documented prior to launch. Launch films showed numerous light colored particles, believed to be pieces of foam, falling along side the SRB plumes during ascent. The HDP Debris Containment Systems (DCS) appeared to have functioned properly and all the plungers were seated.

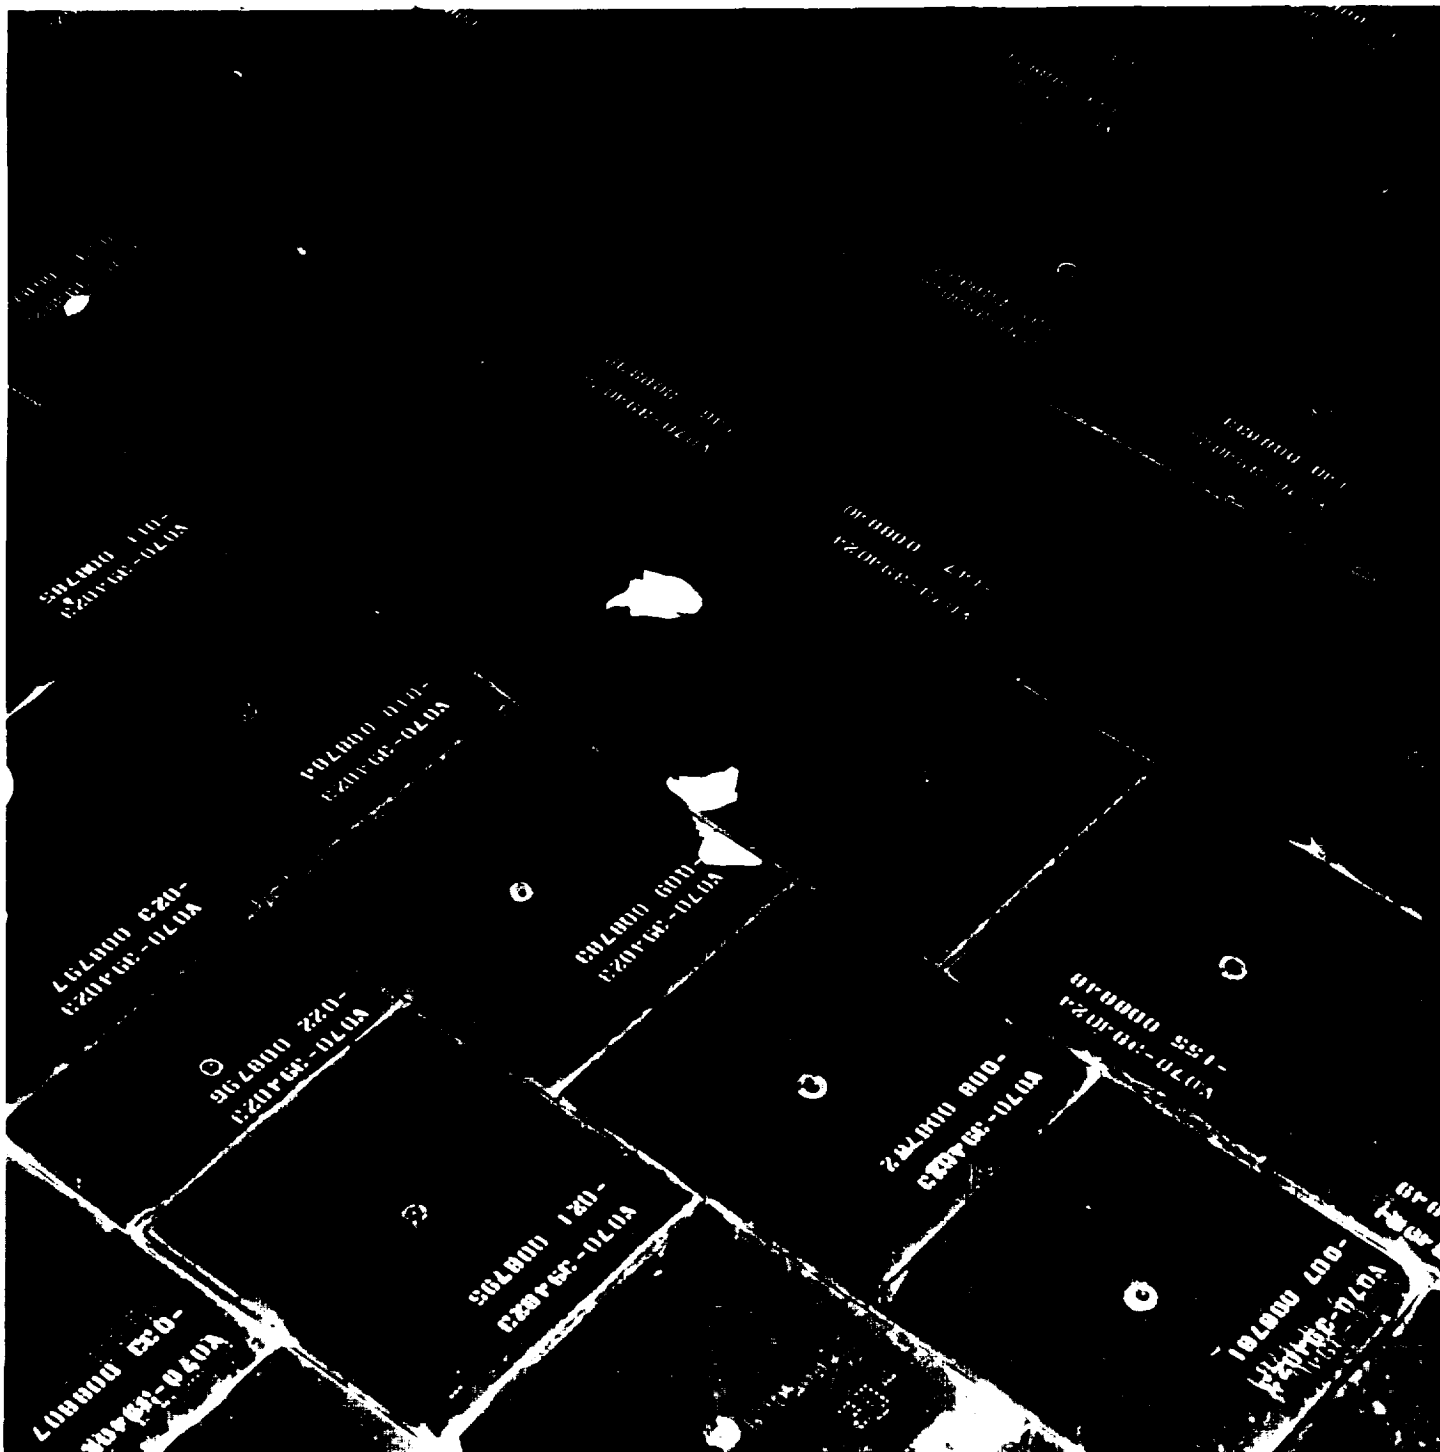
Photo 22: Lower Surface Tile Damage

The Orbiter lower surface sustained a total of 32 hits, of which 5 had a major dimension of 1-inch or larger
